## 6 Structural Intrusive Condition Survey

### 6.1 Synopsis

## 6.2 Introduction

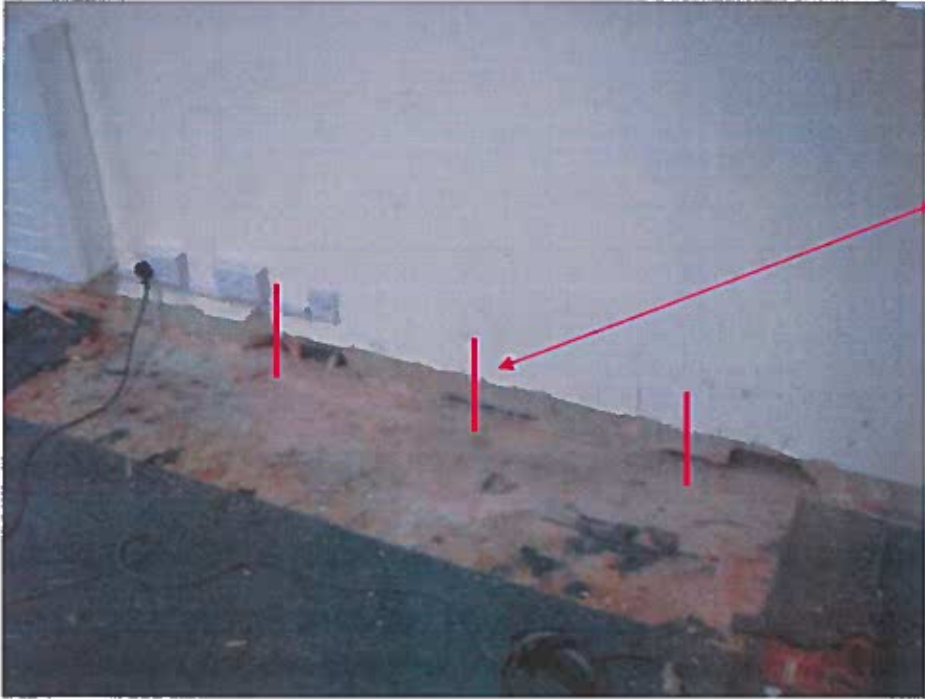
- **Location L1** located at first floor along an external wall. 3No dowel bars at 600mm c/c within the wall panel and 2No service voids (see photo 1). Dowels 26mm dia. plain round bars located at the centre of the precast panel width (see photo 2 typical). Dry pack at base of panel 30mm deep and 80mm wide across the 150mm wide panel. Service voids are rebates cast into the precast wall panel 50mm deep by 100mm in length. The voids are for electrical services embedded within the wall panel and filled with plaster material. Breaking out the dry-pack broke through to the external overlaid panel, which is separated from the inner panel by compressible fill material.

*Photograph 2*  
Breakout L1  
Dowel bar and service void rebate (typical)

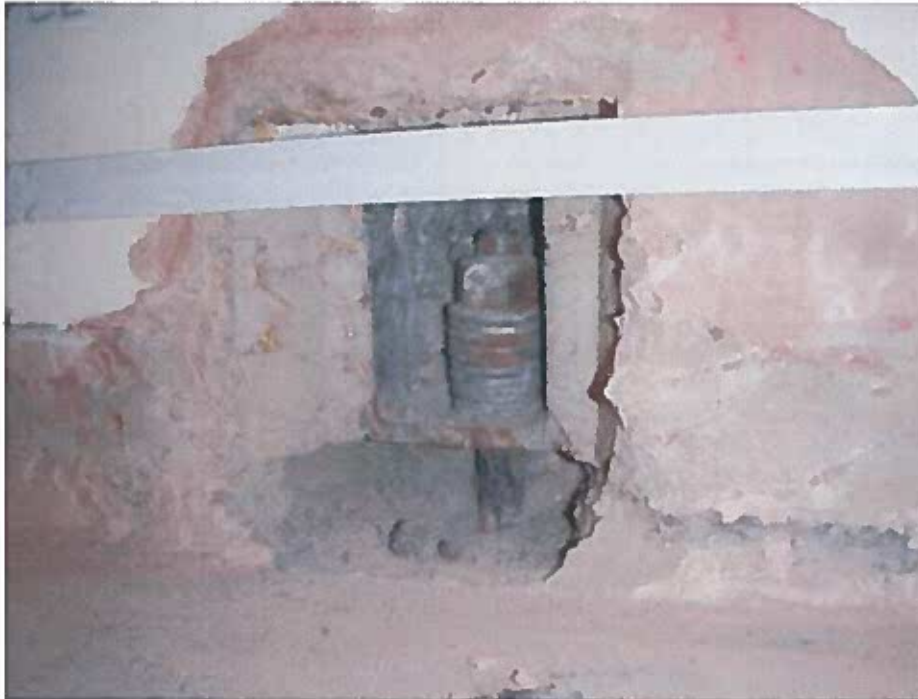
*Photograph 3*

- **Location L2** located at first floor along an internal wall panel exposed a steel box section within the precast panel and levelling dowel bolted down with a 40mm dia. Nut and 10No pack washers (see photo 3). The box section contained a slotted hole on the bottom face to assist locating the levelling dowel. A secondary threaded bar passes through the top flange of the box section and into the remainder of the precast wall panel (see photo 4). A service void rebate was exposed and the dry-pack fill broken out to reveal the panel width as approx 240mm. Dry-pack measured 30mm deep for the full width beneath the precast wall panel.

Breakout L2

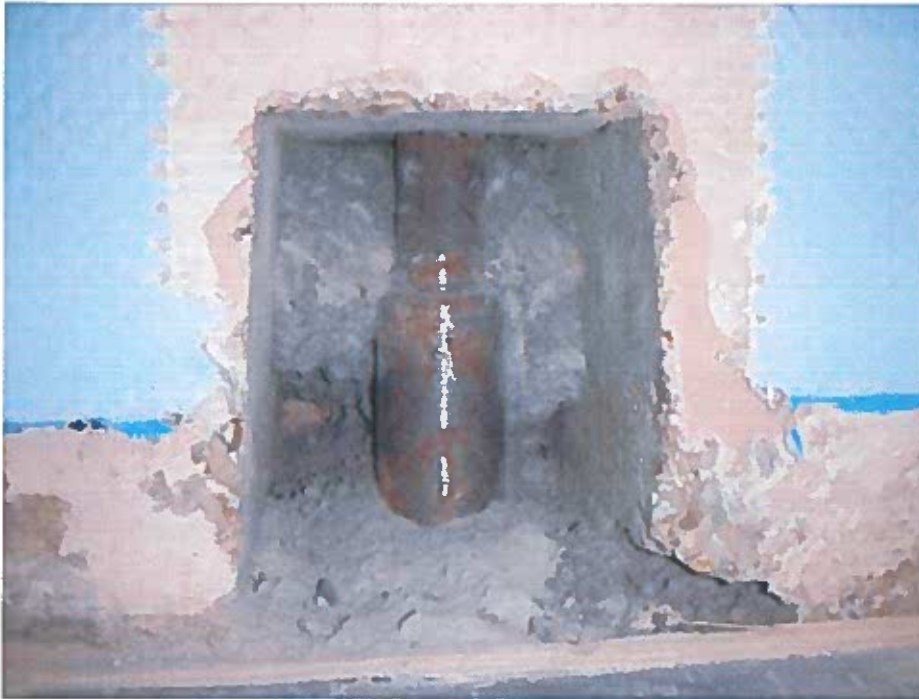
*Photograph 5*

- **Location L3** located at first floor along an internal flank wall revealed 180x130mm rebate filled with dry-pack material. The precast panel contained a 65mm dia. coupler protruding 100mm from the podium level slab and a 40mm dia. threaded dowel bar into a formed void within the precast panel (see photo 5). The coupler and dowel are located at the centre of

Breakout L3

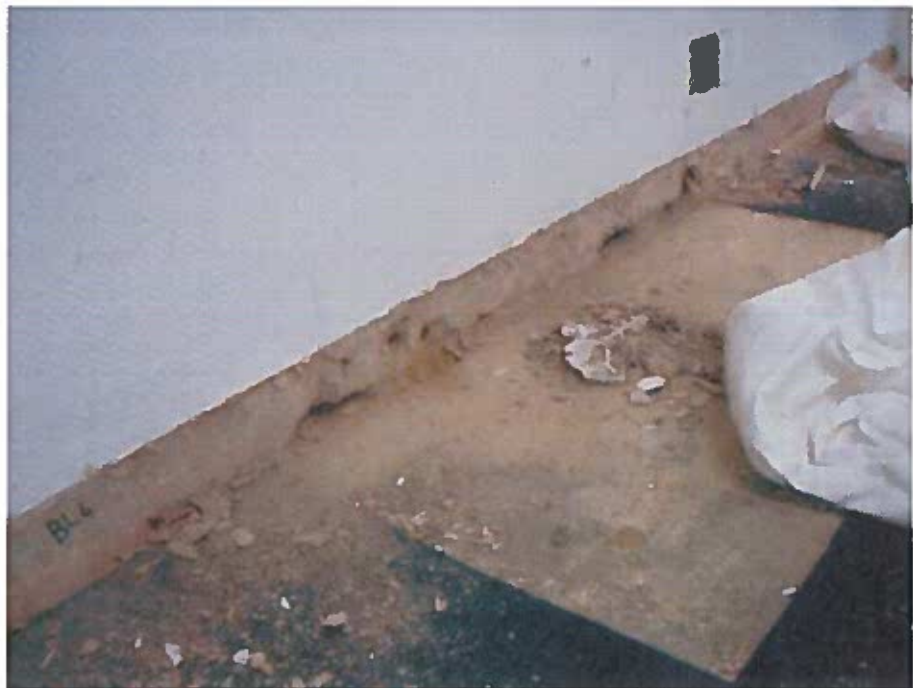
*Photograph 6*

- **Location L4** located at first floor along an external wall panel. The breakout exposed 2No dowels bars at 600mm c/c within the external wall panel and 1No service void (see photo 6). The dowel bars were 26mm dia. plain round bars and set back from the inside face by 57mm. The dry-pack appeared in good condition and measured 20mm deep. The width of the dry-pack is approximately 50mm from each face, giving 100mm overall bearing width. Next to the service void the width measured approx 120mm in total.

Breakout L4

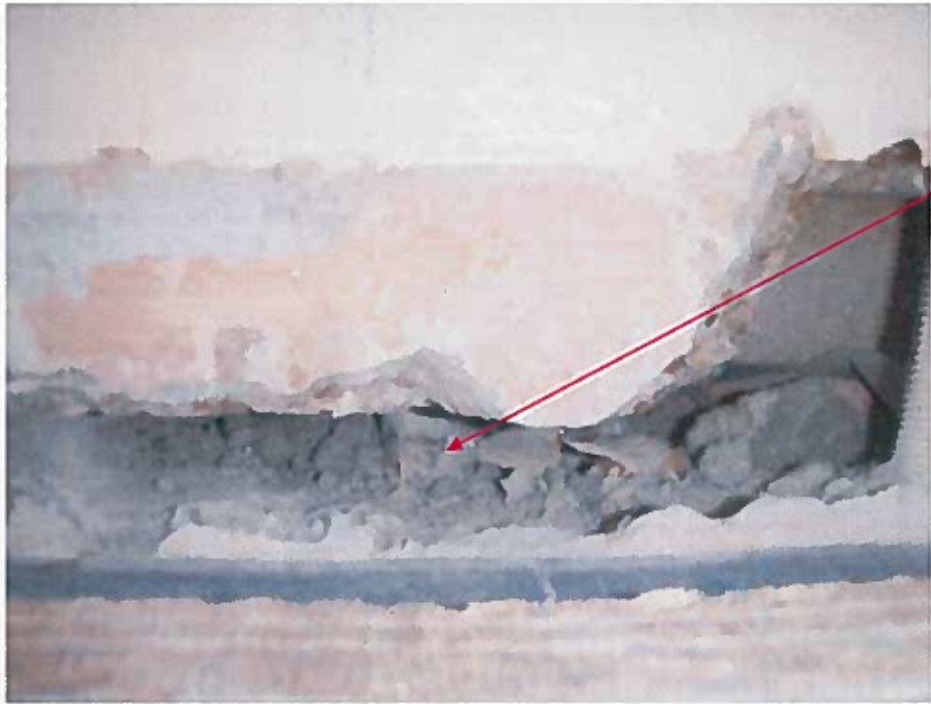
- **Location L5** located on the 6th floor along an external wall panel. The breakout exposed 2No 26mm dia. plain round dowel bars at 600mm c/c within the external wall panel (see photo 7) set back from the inside face by 65mm. The precast panel measured 150mm wide. Dry pack in good condition measuring 25mm deep along the length of the panel and full width across the 150thk panel. A single service void was exposed adjacent to the levelling dowels and appeared to be partly filled with plastic packaging. The overlaid panel was revealed and exposed a plastic fill type fill material (see photo 8).

*Photograph 7*  
Breakout L5  
Exposed dowel bar

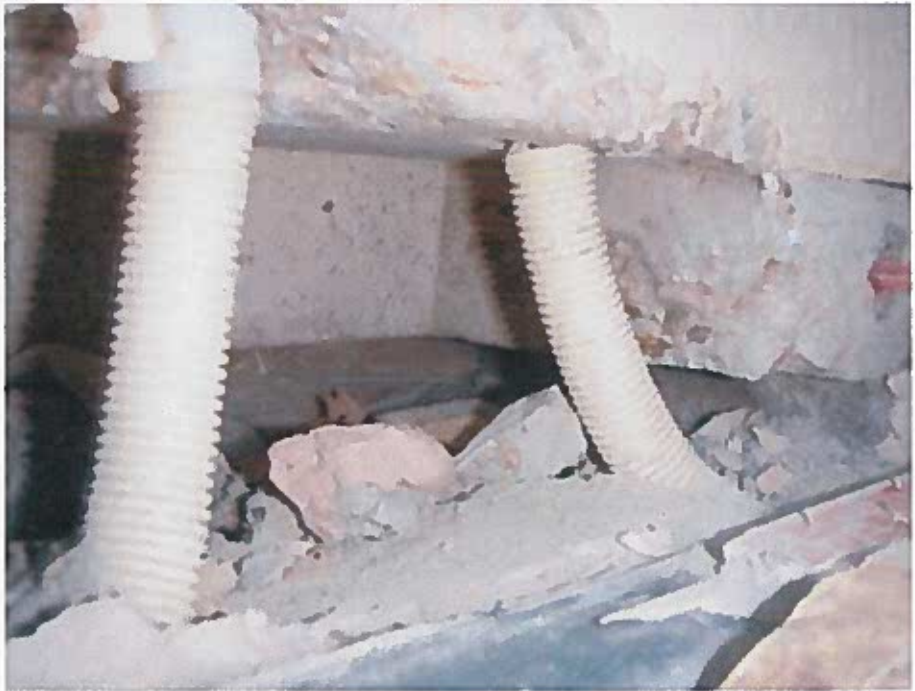
*Photograph 8*  
Breakout L5  
Breakout: exposed plastic fill material behind wall panel

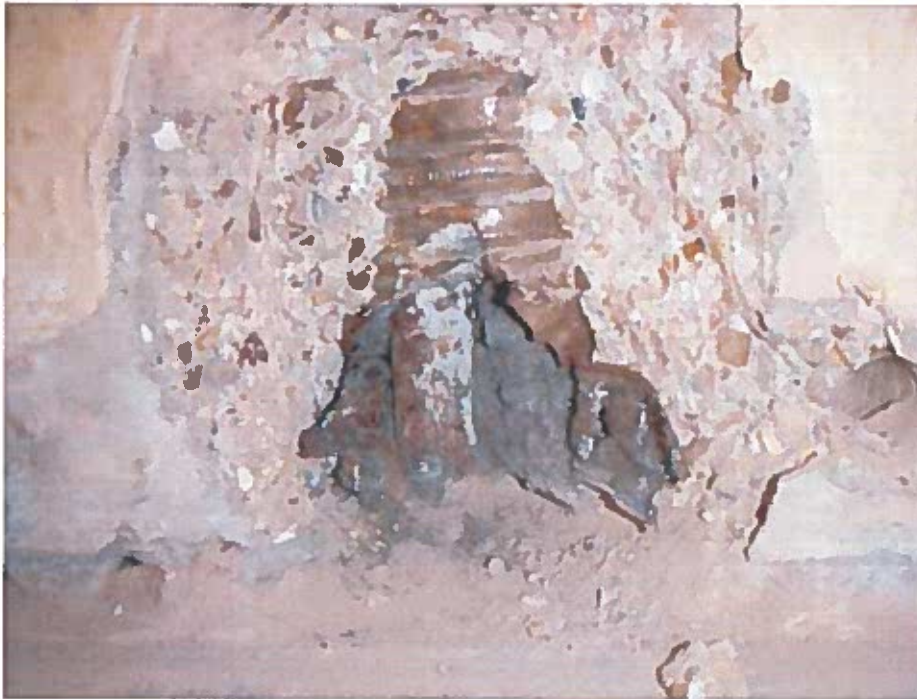
Photograph 9

- **Location L7** located on the 16th floor along an external wall panel. Breakout exposed a service void 50mm deep by 160mm long, along with 2No plain round dowel bars, 26mm dia. at 600mm c/c. The dowel bar runs in a void formed by a 60mm dia. ribbed, metal pipe embedded within the panel (see photo 9). Possibly a typical detail throughout the building. The LHS dowel bar centre was measured to be 2020mm from the external end panel inside face. Dry-pack in good condition and 25mm in depth and installed across the full width of the 150mm wide panel including the infill to the service void (see photo 10).

Breakout L7

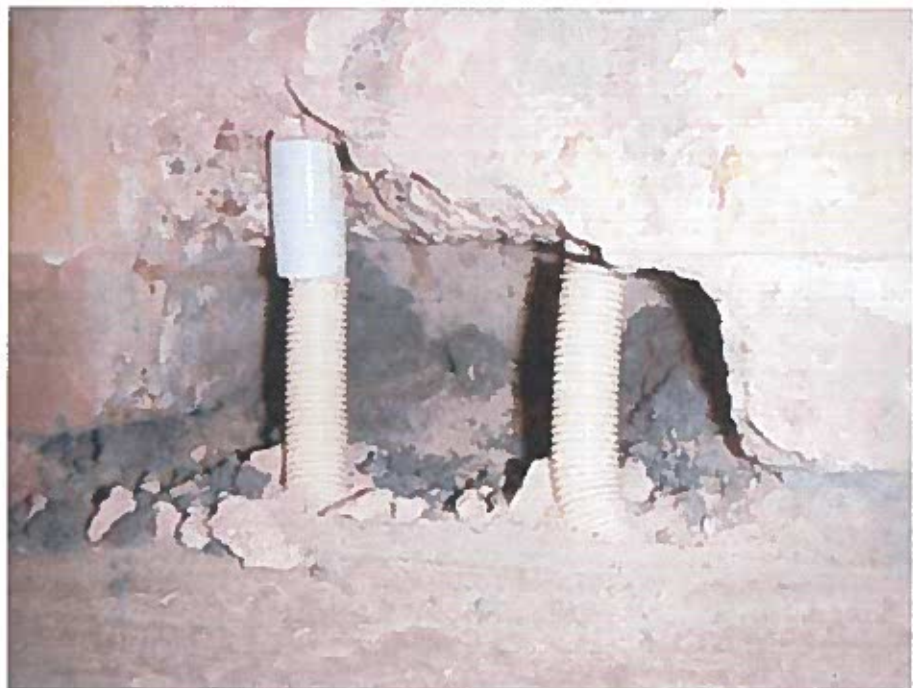
- **Location L8** located on the 16th floor along an external wall panel. 2No plain round dowel bars, 26mm dia. at 600mm c/c (see photo 11), with a service void, infilled dry-pack mortar. The service void measured 100mm deep into the panel from the inner face. The dry-pack

*Photograph 11*  
Breakout L8

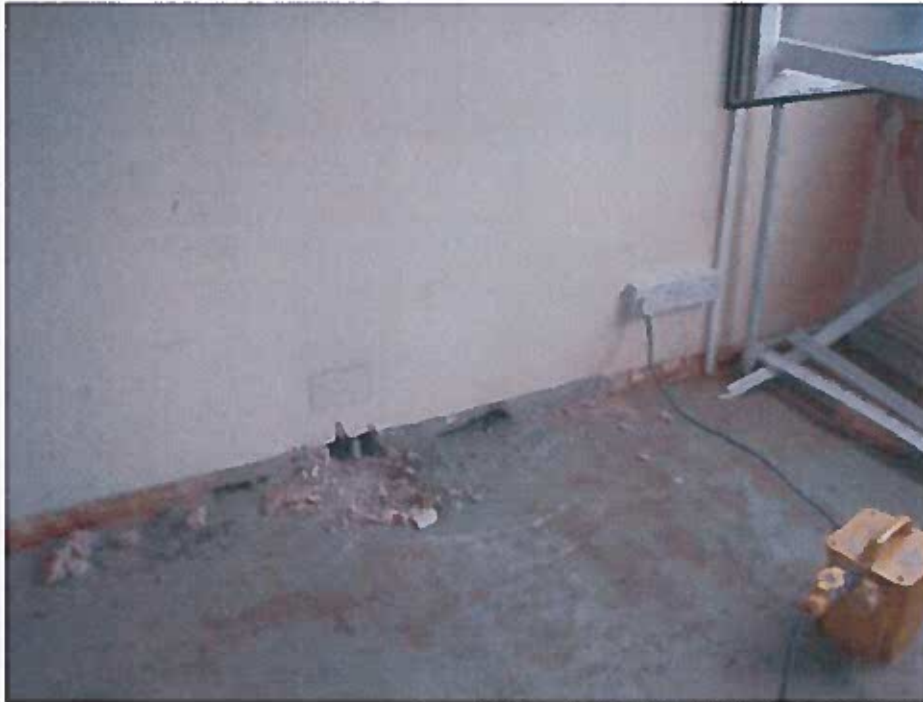
was 35mm in height and was consistent across the full width of the panel (see photo 12). The void between the overlaid panel and the load-bearing panel was filled with compressible air-filled packing material (see photos 12 & 13).

*Photograph 12*  
Breakout L8  
Dry-pack mortar in good condition and across the panel width

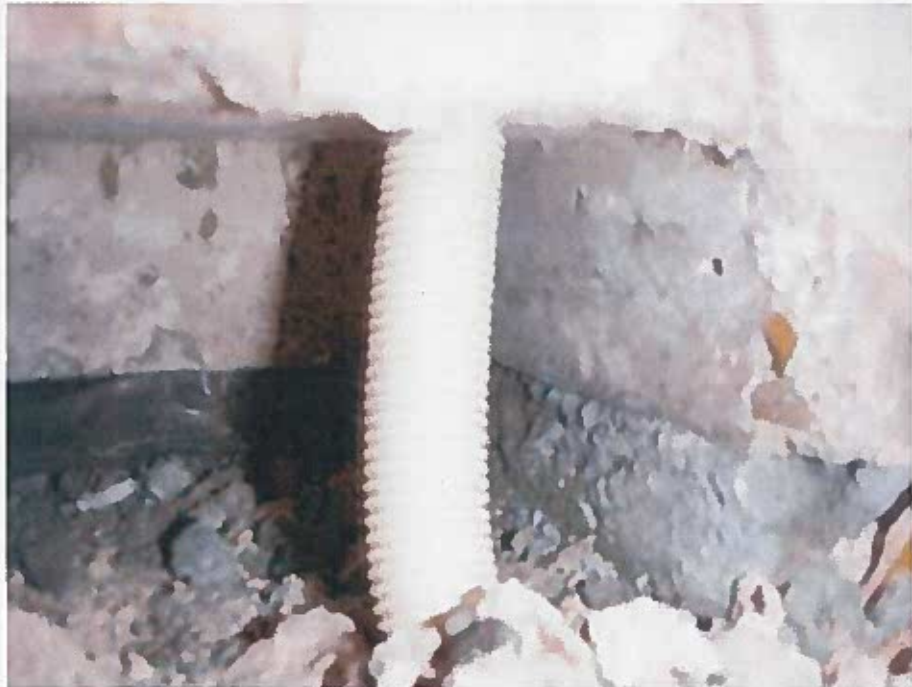
***Photograph 13***  
Breakout L8  
Air-filled compressible fill material at rear of panel

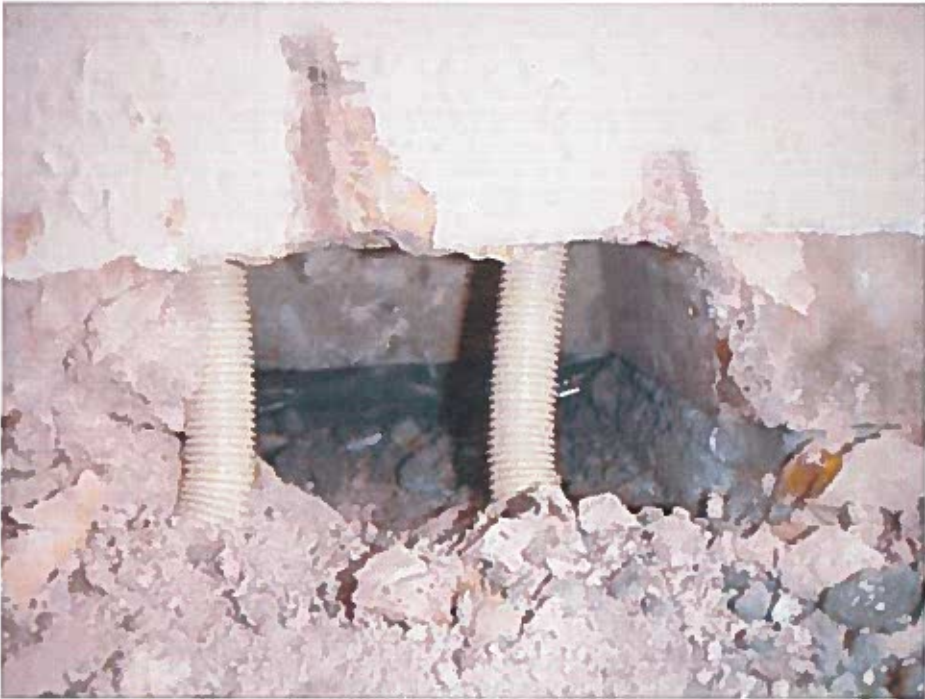
- **Location L9** located on the 16th floor along an internal wall panel. The breakout exposed a large 230x200mm rebate within the wall filled with a combination of dry-pack and plaster (see photo 14). Within the rebate a threaded 26mm dia. dowel bar protruded out of the floor slab and coupled into a secondary 42mm dia. bar running vertically into the panel within a cast-in void. A second threaded dowel bar was exposed at 600mm c/c further along the wall (see photo 15). This is the only breakout where threaded dowel bars were observed. Three service voids were exposed within the breakout, all 190mm apart. The dry-pack appeared full width across the 240mm wide panel and measured 35mm in depth. Areas of reduced dry-pack width at the service voids 50-60mm from each side. Shims left within the void between slab and underside of precast panel (see photo 16) were not loaded.

***Photograph 14***  
Breakout L9  
Coupler system at floor 16 within internal wall panel

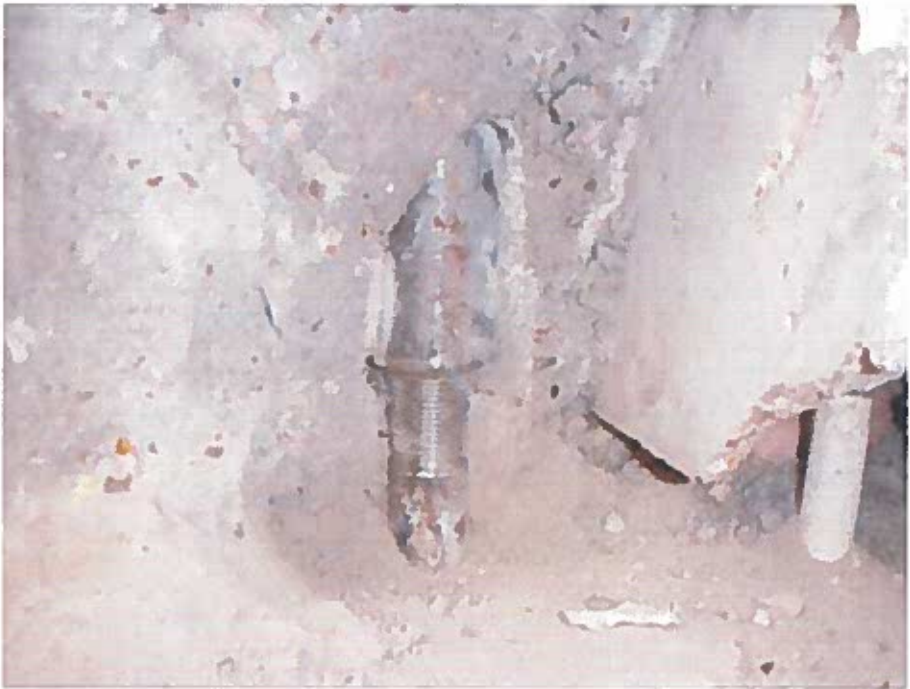
Photograph 15  
Breakout L9  
Threaded dowel bar protruding into precast wall panel

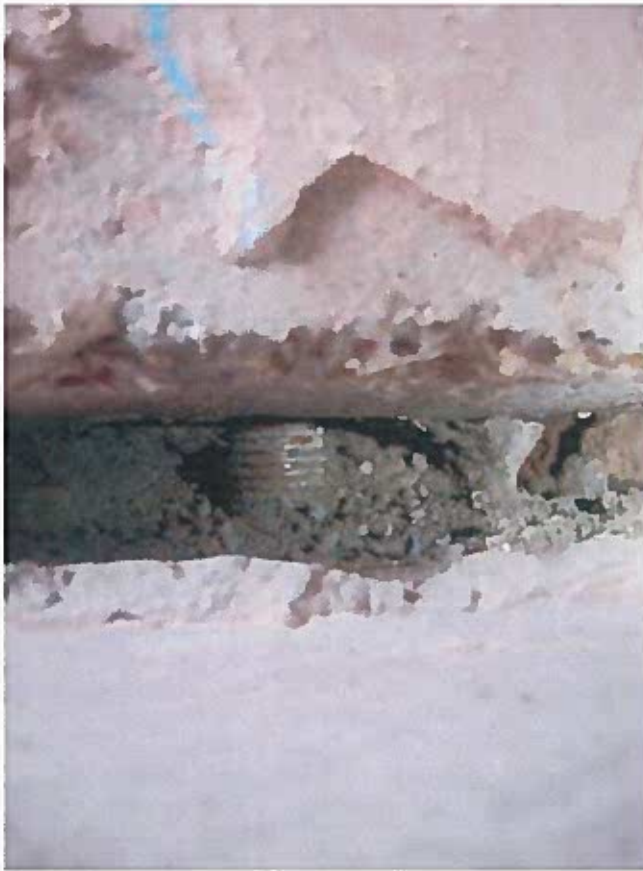
Photograph 16  
Breakout L9  
Shim observed in void beneath panel

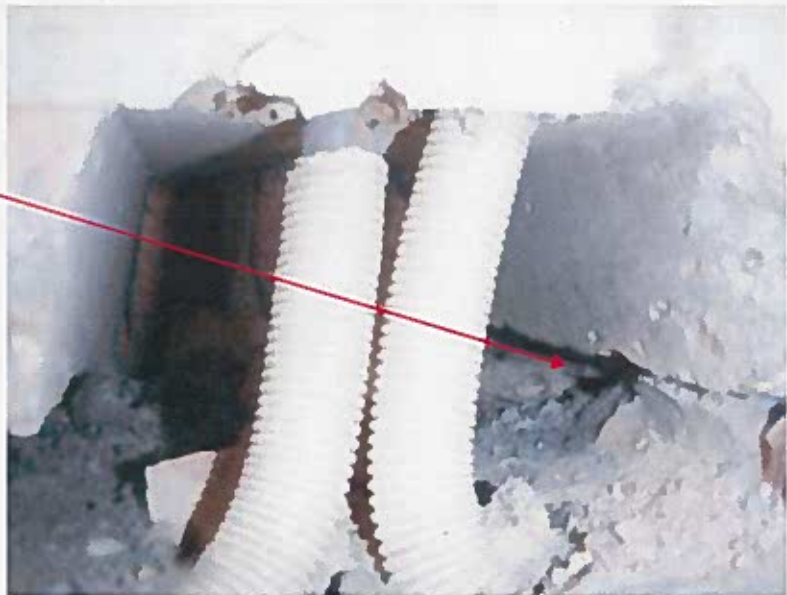
- **Location U1** located on the first floor along an internal wall panel exposing the bearing and insitu infill between the floor slab and the top of the wall panels. 15mm slab bearing with no bedding material present with the slab bearing directly onto the wall panel (see photo 17). The breakout was not large enough to expose any tying rebar.

**Photograph 17**  
**Breakout U1**  
Ceiling level breakout showing the different concrete elements (shades) within the joint

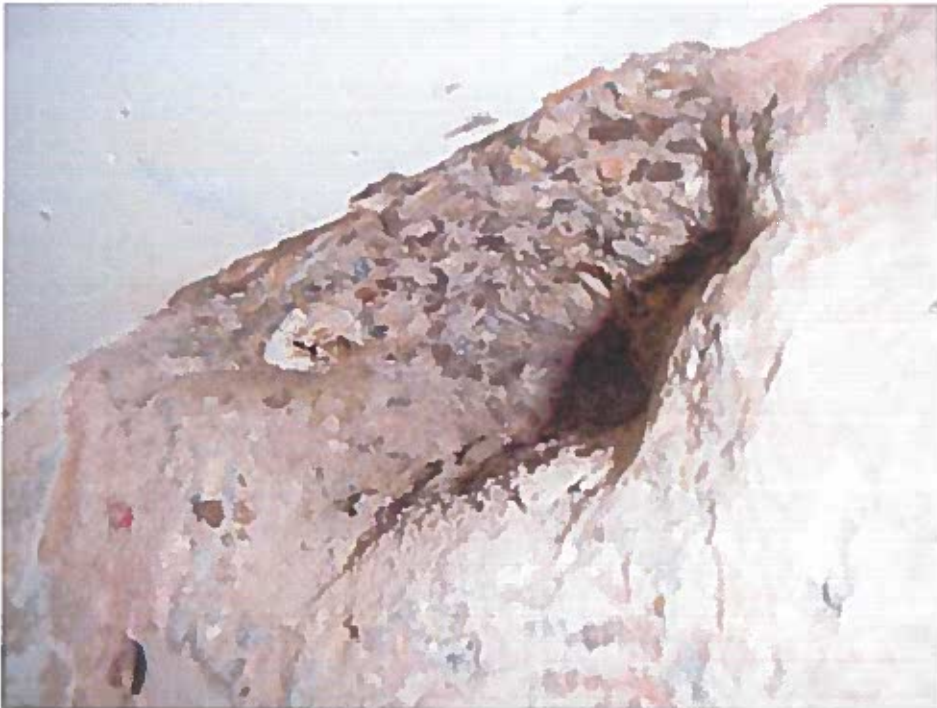
- **Location U2** located on the first floor along an external wall panel. The breakout exposed several reinforcing bars within the slab, wall panel and insitu infill concrete (see photos 18 & 19). Tying reinforcement both horizontally and vertically present within the concrete infill. The horizontal tie appears to be 10mm dia. plain reinforcing bar, hooking around the main reinforcement (possibly 16mm dia.) within the infill joint; the anchorage length into the slab is unknown. The vertical tie (10mm dia. plain bar) protrudes from the wall panel into the infill; it is unclear whether there is a hook on the end of the bar within the infill; anchorage length into the wall panel is unknown. The slab main reinforcement was 16mm dia. in the span direction with 10mm dia. distribution bars with 15mm cover as the outer layer. 16mm dia. reinforcement bar with 30mm cover in the wall panel. No vertical reinforcement was

**Photograph 18**  
Breakout U2 tying reinforcement at wall – soffit joint at first floor

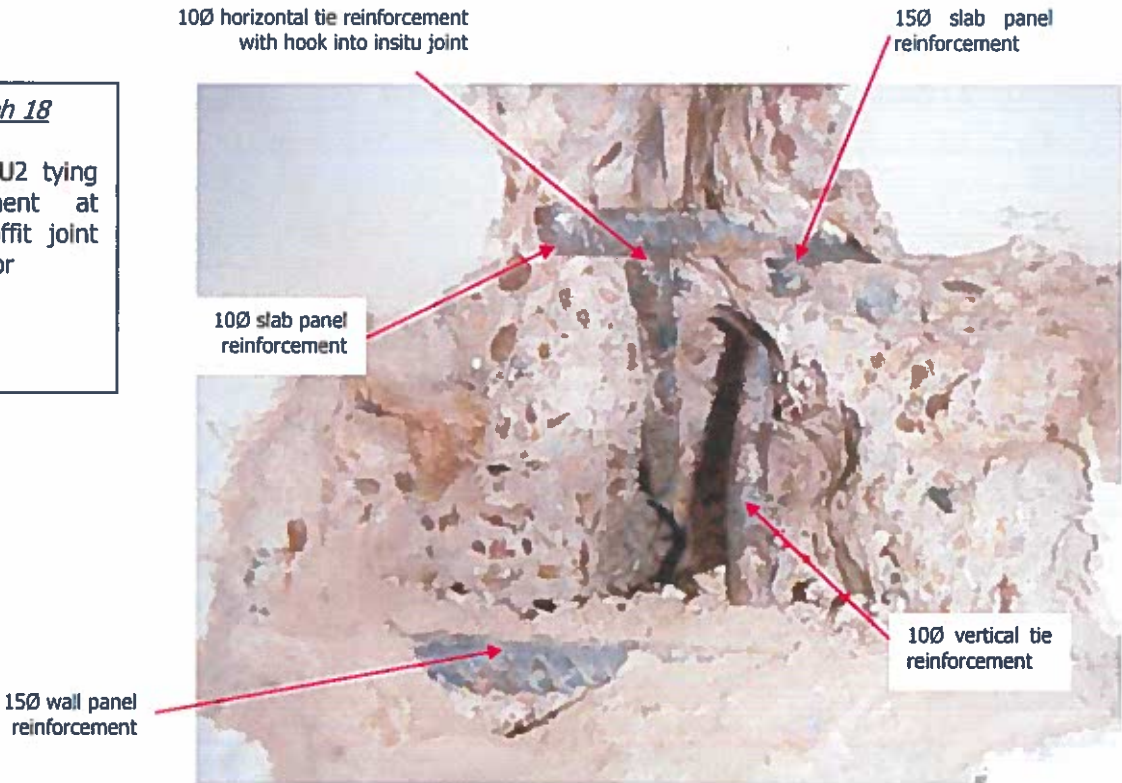
**Photograph 19**  
Breakout U2 tying reinforcement at wall – soffit joint at first floor

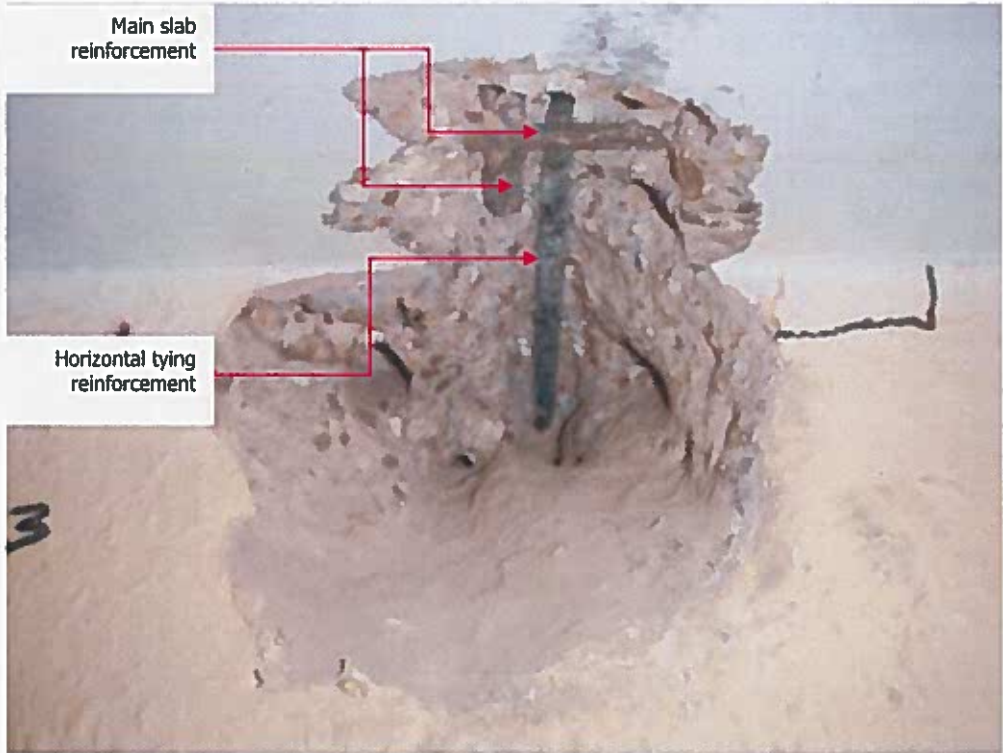
- **Location U3** located on the 16th floor along an internal wall panel. The breakout exposed horizontal tying reinforcement (10mm dia. plain bar) which appeared to continue through the concrete infill and into the adjacent precast slab panel (see photo 20 & 21). This detail is unconfirmed but assumed due to the extent of breakout with no evidence of the rebar hooking around secondary bars as was demonstrated in location U2. No vertical tying rebar was revealed; however, it is assumed the breakout avoided further rebar given its spacing. Main reinforcing bars exposed within the floor slab panel with 16mm dia. main steel and 8mm dia. plain round distribution bars with 20mm of cover. Reinforcement in the precast wall panel was not exposed. The bearing of the slab onto the wall panel measured as 45mm. The distance to centre of horizontal tying rebar was 460mm from the edge of the slab panel.

*Photograph 21*  
Breakout U3 tying reinforcement at wall – soffit joint at 16<sup>th</sup> floor

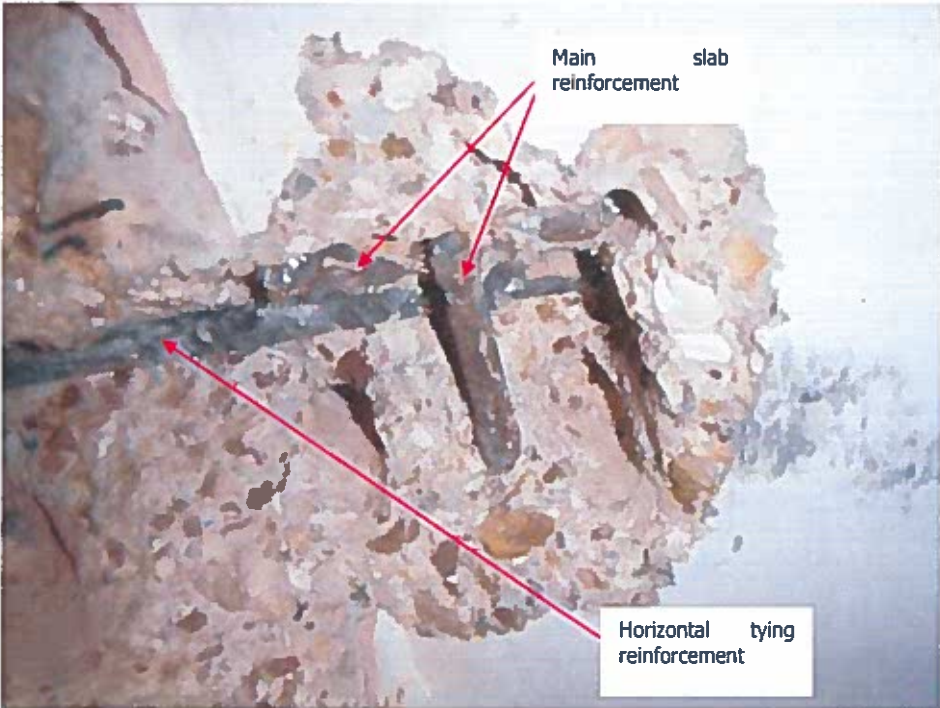
- **Location U4** located on the 16th floor along an external wall panel. The breakout exposed both vertical and horizontal tying reinforcement within the joint, together with the main reinforcement present within the slab panel (see photo 22 & 23). Tying reinforcement measured 10mm dia. plain bars tied into the insitu concrete joint. The slab reinforcement appears to be 16mm main bars and 8mm distribution bars as elsewhere, with 25mm cover in the minor direction. The horizontal and vertical ties are located 255mm c/c apart within the breakout, with the horizontal tie 1360mm from the slab panel edge. The bearing of the slab onto the wall panel was measured as 20mm. The breakout did not expose any main reinforcement within the wall panel.

*Photograph 22*  
Breakout U4 tying reinforcement at wall – soffit joint at 16<sup>th</sup> floor

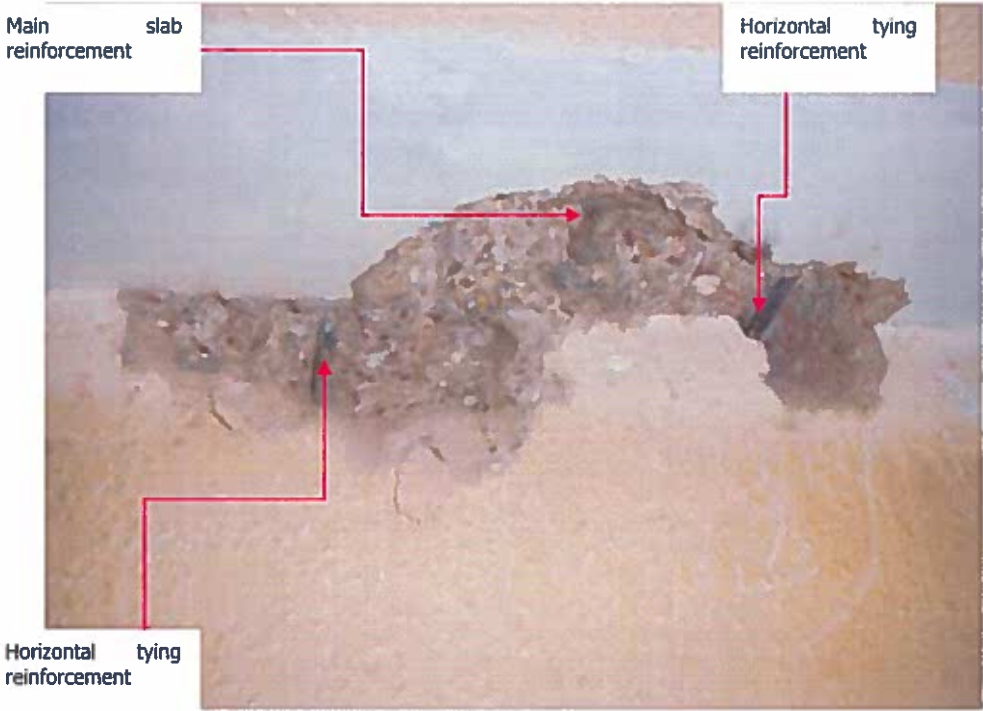
*Photograph 23*  
Breakout U4 at wall – soffit joint at 16th floor  
Slab            main  
reinforcement

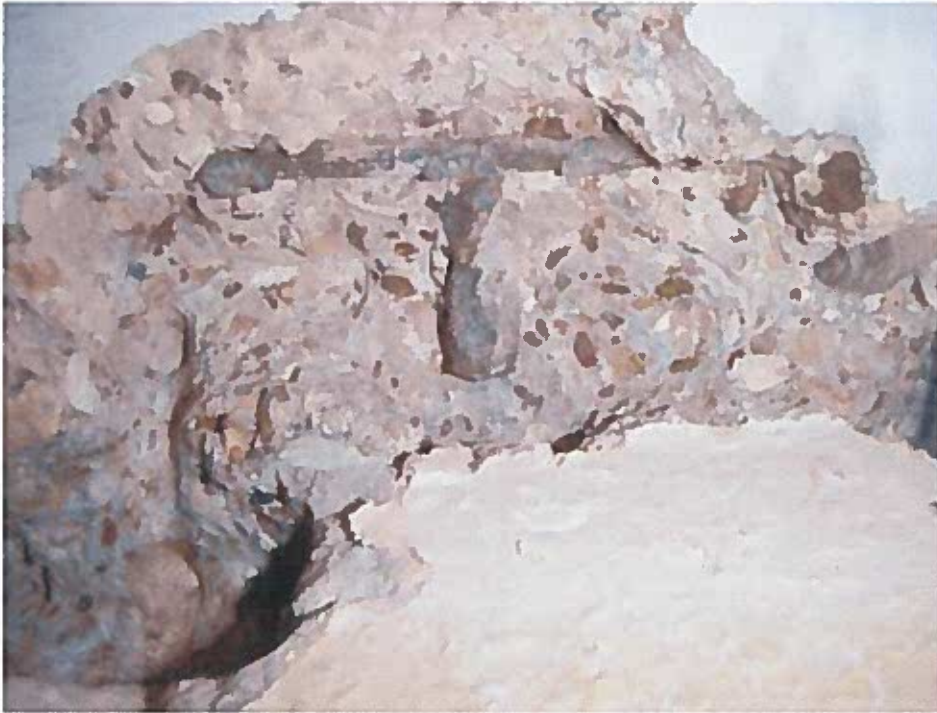
Test areas AB1, AB2 and AB4 have locally exposed corroded reinforcement. Photograph 24 shows the localised area of exposed reinforcement, which appears to be a horizontally running bar with exposure at the trough of the rib within the panel.

- 6.5.3.3 In isolated locations in the external ribbed panels, the cover survey revealed minimal (or no) cover to horizontal reinforcement in the troughs of the ribs. These areas will also require remedial repairs moving forward.

*Photograph 24*  
Test area AB1 showing exposed horizontal reinforcement

- 6.5.5.2 It must also be highlighted that any proposals for an over-cladding of the structure should be subject to structural review in respect of loading and fixings etc.
- 6.5.5.3 With regard to repair works, and as noted in 6.5.3 above, consideration must be given to the repair of the local areas of spalled concrete as identified in Ref A.
- 6.5.5.4 Additionally and outside the remit of concrete repairs, works also highlighted in Ref A (repeated within Appendix A) include attention to areas of loose render, fixings of roof balustrades and handrail provision at roof level together with the strengthening/replacement of a steel beam supporting the water tank at high level plant room.
