## TYPE 2 ASBESTOS SURVEY OF

**The Rowans  
College Street  
London Road  
Leicester  
LE2 0JH**

AOH REPORT No: LEC/A1/18308L  
Issue Date: 3<sup>rd</sup> April 2008

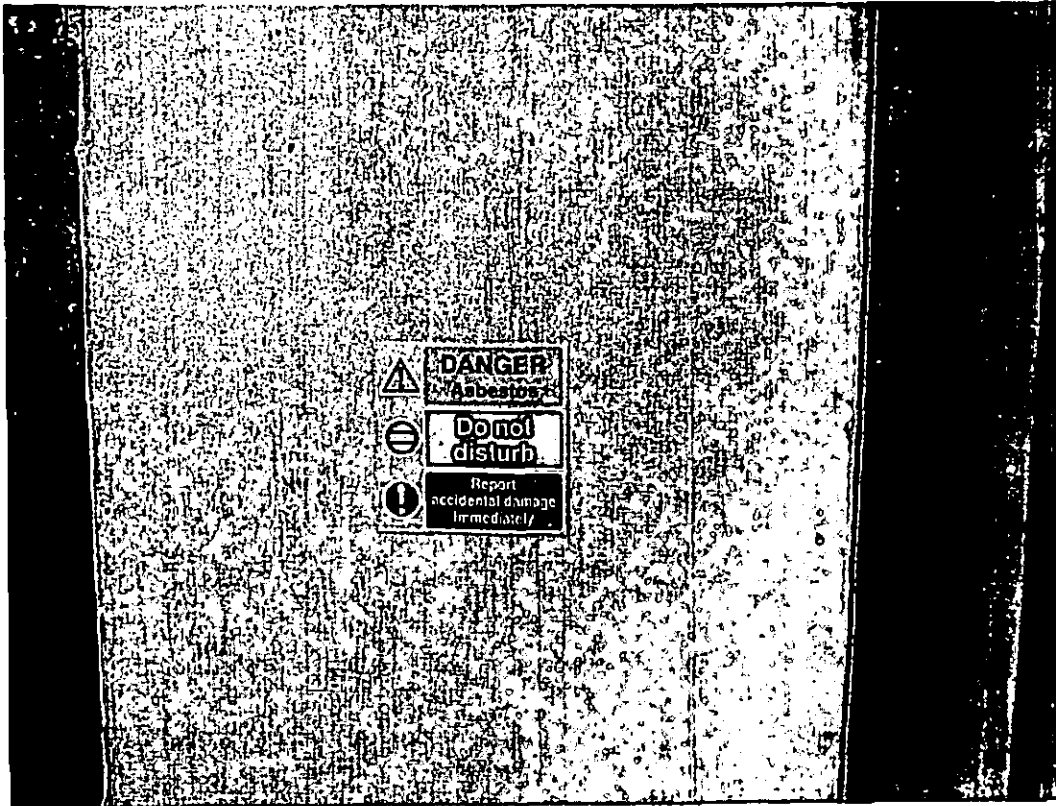
<b>Ref</b>	<b>Room</b>	<b>Location</b>	<b>Type of Asbestos</b>	<b>Total Risk Assessment</b>
01/5	BIKE STORE	BOARDS TO DOOR	AMOSITE	11

Boards to doors in the above reference location were found to contain Amosite (Brown asbestos), see Photo Ref: 1.

Photo 1 Ref: 01/5 . Boards to doors containing Amosite.

They are labelled and may be left in situ.

When removal is required they should be removed with doors intact and disposed of as asbestos waste, a licensed asbestos contractor should be used to carry out the works in accordance with the removal of asbestos regulations 2006.
