REPORT
OF
**BRAUNSTONE HALL ROOFING
AREAS**

for
Leicester City Council

Project Nr. 80607

April 2012

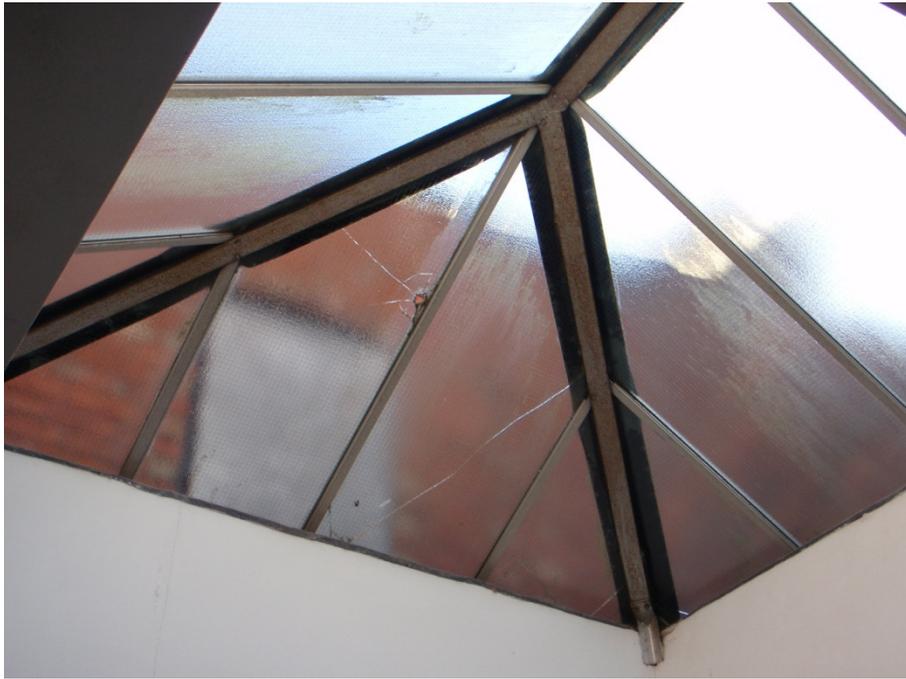
Access is available via a door leading onto the roof. The area is covered with felt (Photo 2) and is partially covered by a lantern skylight (Photo 1).

There are currently 3 no. glazing panels to the lantern light which are broken and replacement glazing is required. The lantern skylight has been stripped of lead and is currently temporarily lined with self-adhesive materials e.g. flashband to prevent rainwater leaks.

Photo 1 – Broken Glazed Lantern

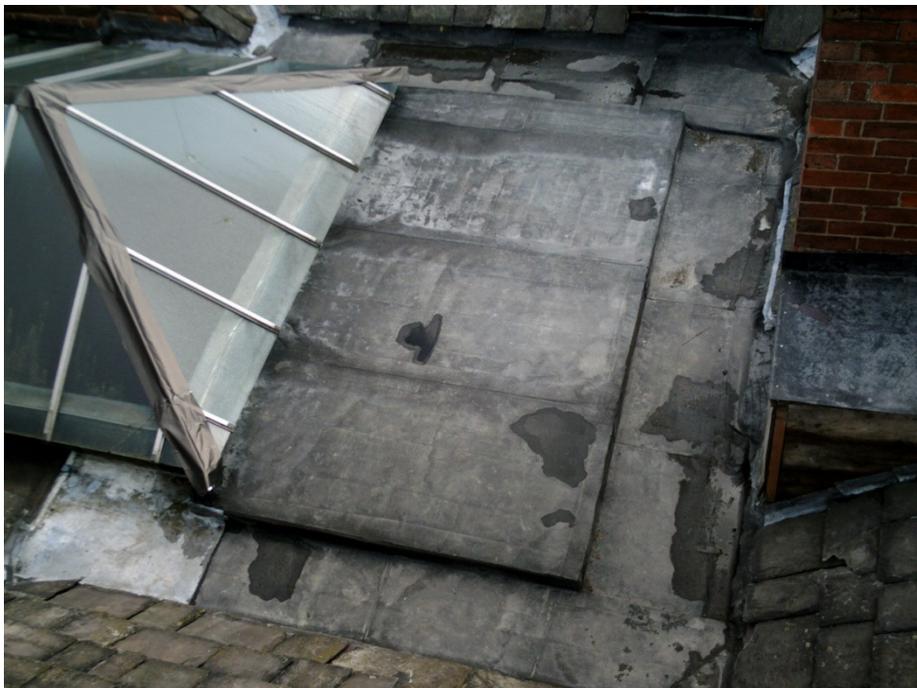
Photo 2 – Central flat area to main roof
Covered with substitute felt material

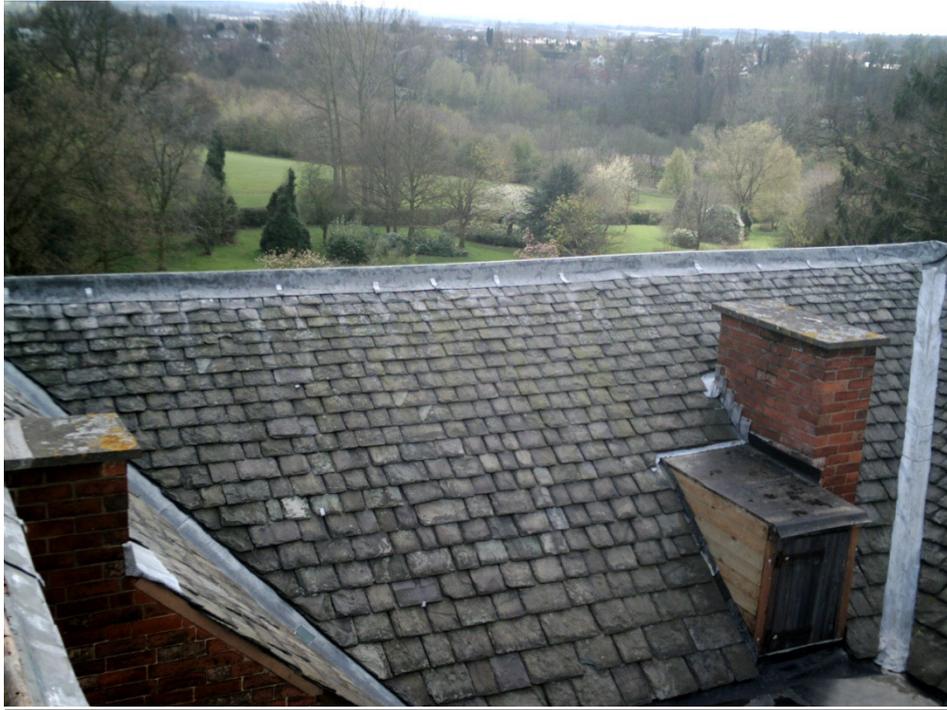
The roof covering is generally in satisfactory condition (Photo 3). However, there is slate slipping in isolated areas as evidenced in Photo 9. This photo shows internal damage likely caused by slate slippage on the roof above. These will require re-fixing or replacement.

Photo 3 – Inner pitch of main roof
Taken whilst work was in progress.

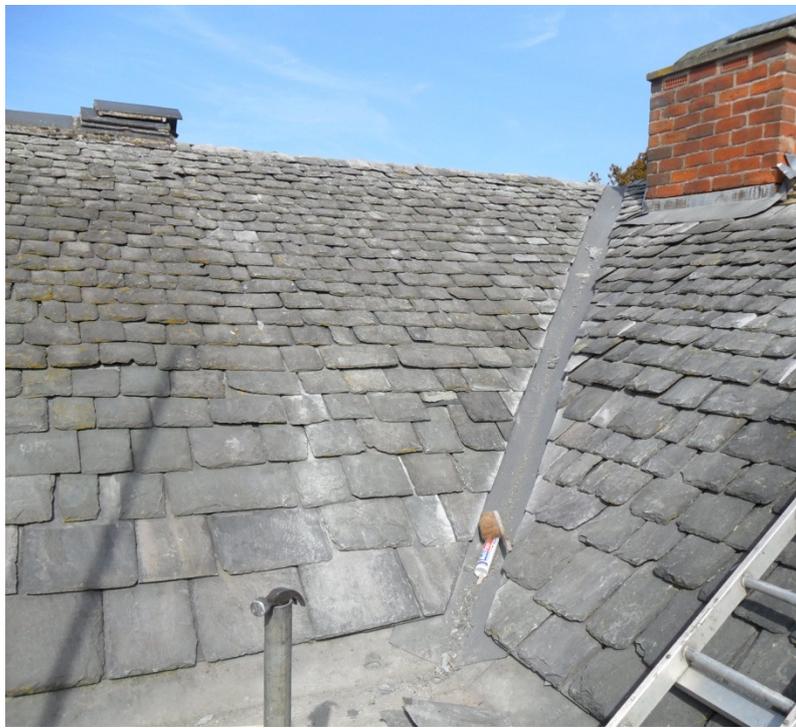
There is a continuous pitched roof around the quadrangle building (Photo 5). The roofs are covered with Swithland slate and clay ridge tiles. The areas surrounding the valleys are in good condition after recent work to them (Photo 4).

Photo 4 – Valleys to quadrangle roof
As above

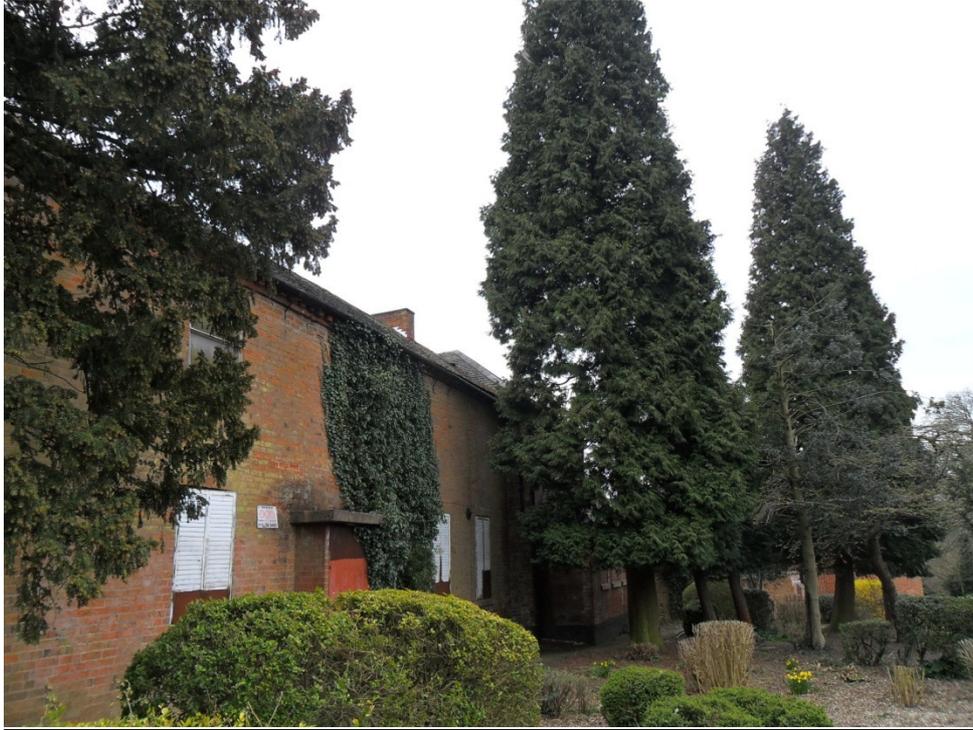
There are isolated areas of slipped slates. These should be replaced or refixed.

Photo 5 – Quadrangle Roof

Note: Vegetation growth around eaves gutter

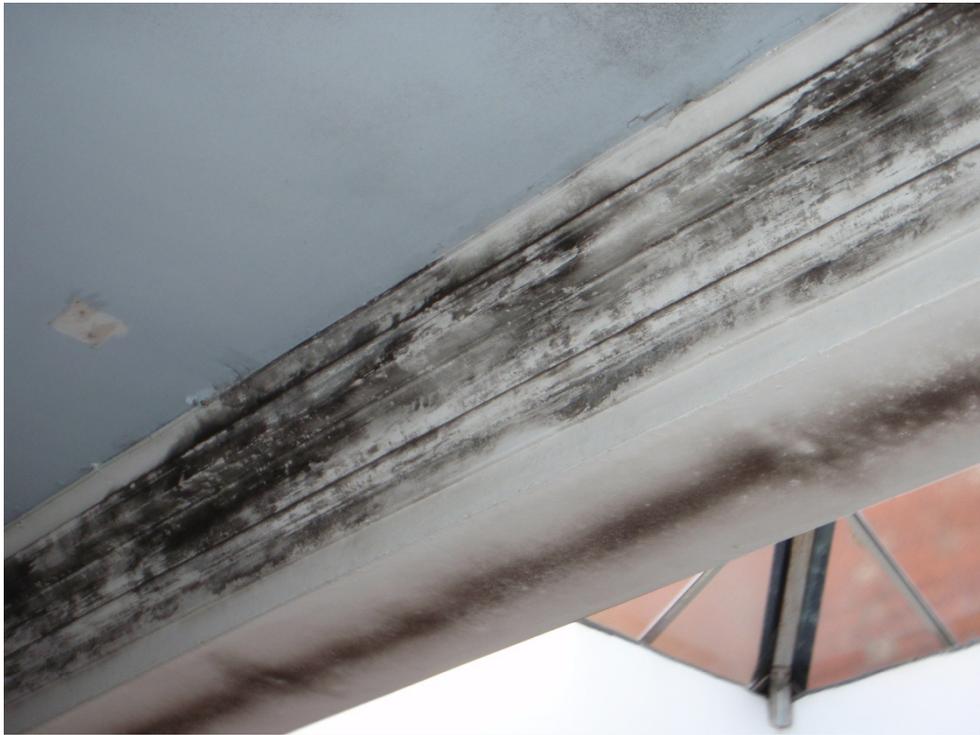
The roof covering to the main hall is of Swithland slate. It is a traditional design allowing the rainwater to flow towards the gutters. Centrally to the roof is a central flat area which contains a glazed skylight. Water to this flat area is disposed of by a secret lead lined box gutter. It was noted internally that water staining to the ceiling is apparent (Photo 6). The water staining is likely to be as a result of the gutter overflowing from a blockage within the gutter.

Photo 6 – Black spot mould staining underneath central flat area of main roof

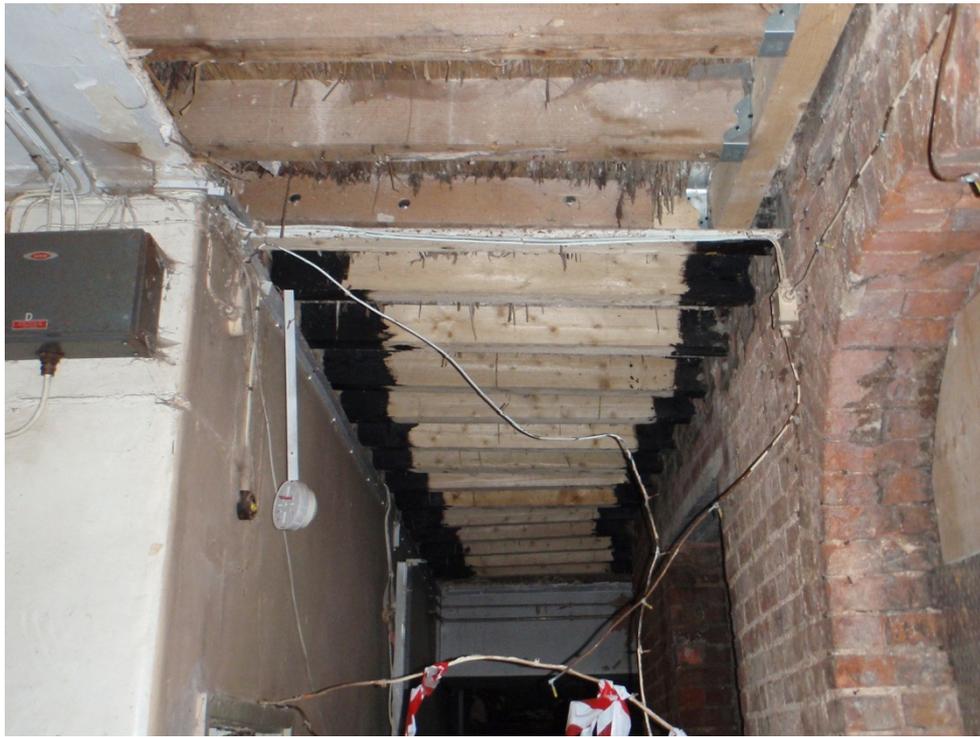
Dry rot has previously been present in the property. This is likely to have been caused by water penetration through leaking roofs, bad ventilation and high humidity (Photo 7).

Photo 7 – Replacement timbers in quadrangle area after dry rot works

No dry rot was apparent during the inspection. It is recommended that the building is regularly inspected for further rot and the roofs are kept in good order to avoid further rot.

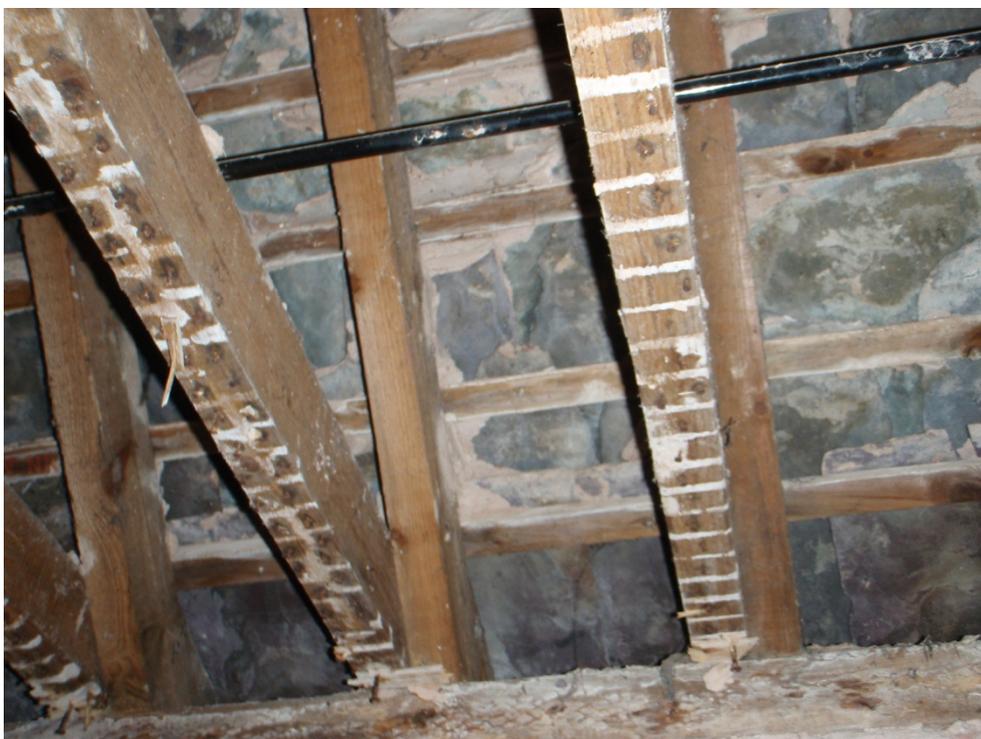
Due to the age of the property, roof insulation is minimal (Photo 8). However as per the requirement of Building Regulations Part L, Schedule 1 should a roof be altered, insulation is required which provides a U value of (0.16 W/m².k at ceiling level and 0.18 W/m².k at rafters' level). Allowance must be made in any re-roofing of the roofs at Braunstone Hall.

Photo 8 – Evidence of no insulation in roof space

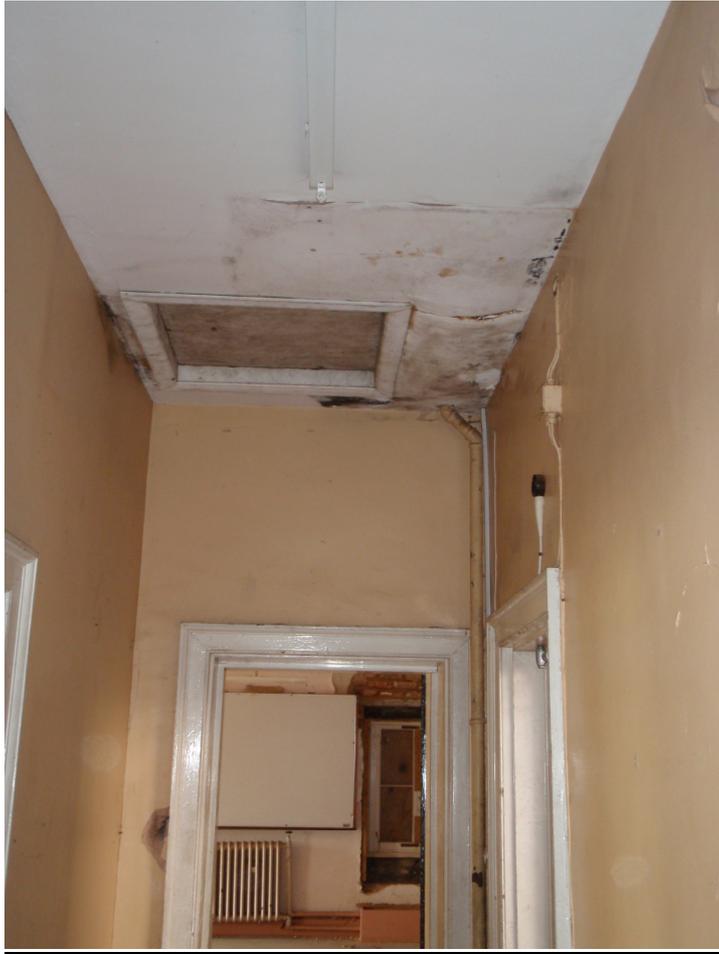
Photo 9 – Visible leak in main roof area
