## 6 Structural Intrusive Condition Survey

### 6.1 Synopsis

## 6.2 Introduction

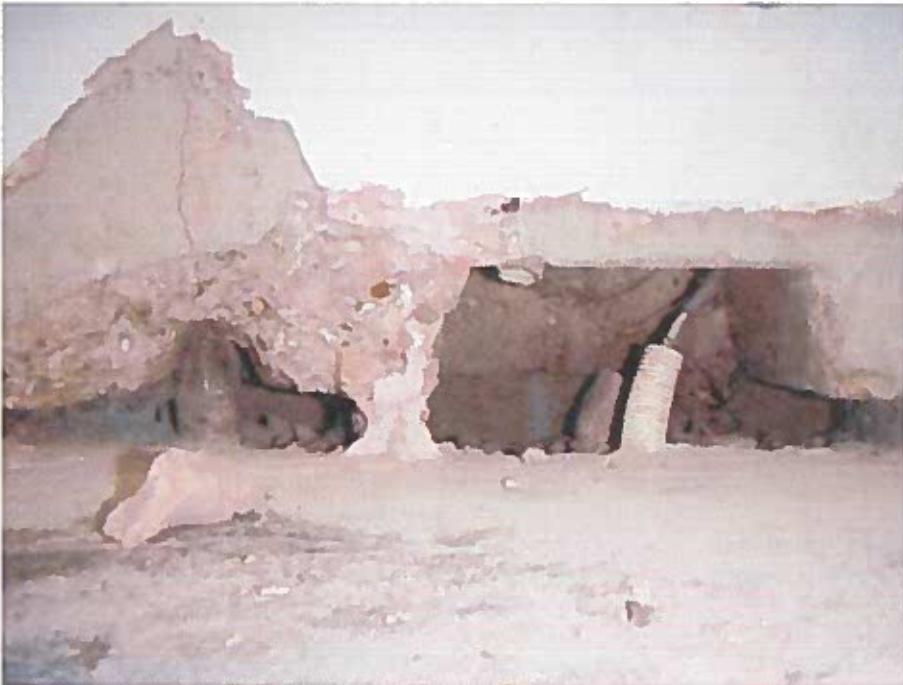
- **Location L1** located at first floor along an external wall. 3No dowel bars at 600mm c/c within the wall panel and 2No service voids (see photo 1). Dowels 26mm dia. plain round bars located at the centre of the precast panel width (see photo 2 typical). Dry pack at base of panel 30mm deep and 80mm wide across the 150mm wide panel. Service voids are rebates cast into the precast wall panel 50mm deep by 100mm in length. The voids are for electrical services embedded within the wall panel and filled with plaster material. Breaking out the dry-pack broke through to the external overlaid panel, which is separated from the inner panel by compressible fill material.

*Photograph 2*  
Breakout L1  
Dowel bar and service void rebate (typical)

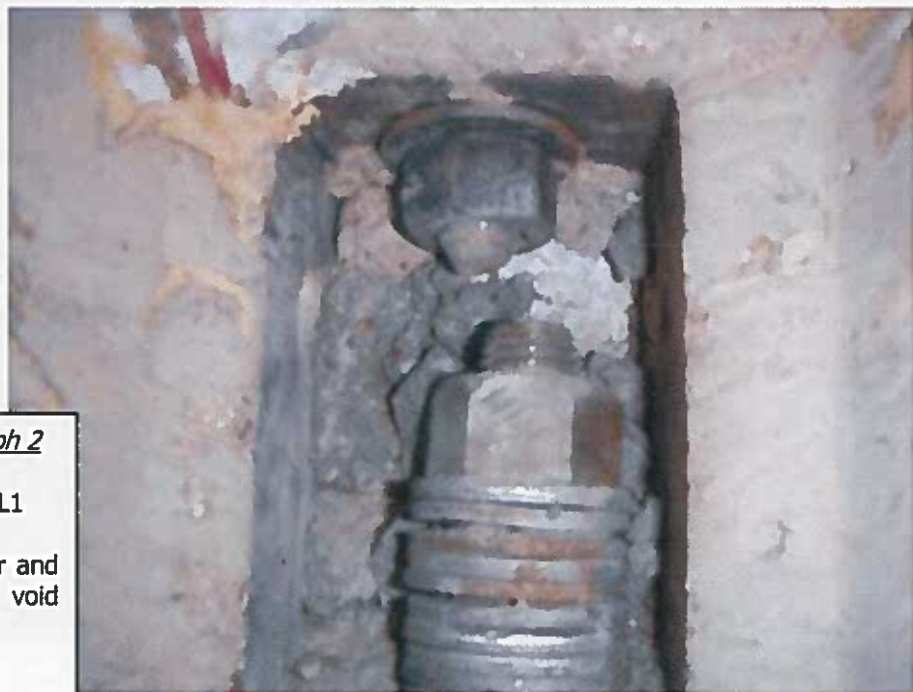
Breakout L2

Threaded and  
bolted bar  
connecting into  
box section

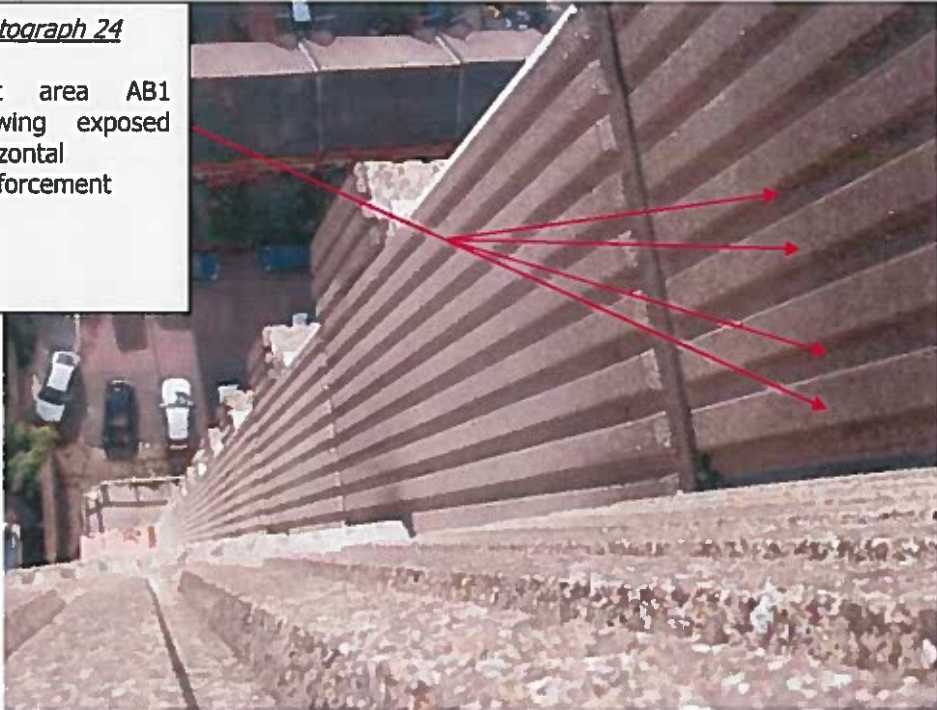
Test areas AB1, AB2 and AB4 have locally exposed corroded reinforcement. Photograph 24 shows the localised area of exposed reinforcement, which appears to be a horizontally running bar with exposure at the trough of the rib within the panel.

- 6.5.3.3 In isolated locations in the external ribbed panels, the cover survey revealed minimal (or no) cover to horizontal reinforcement in the troughs of the ribs. These areas will also require remedial repairs moving forward.

*Photograph 24*  
Test area AB1 showing exposed horizontal reinforcement
